## Appendix A

### Site Reconnaissance Photographs

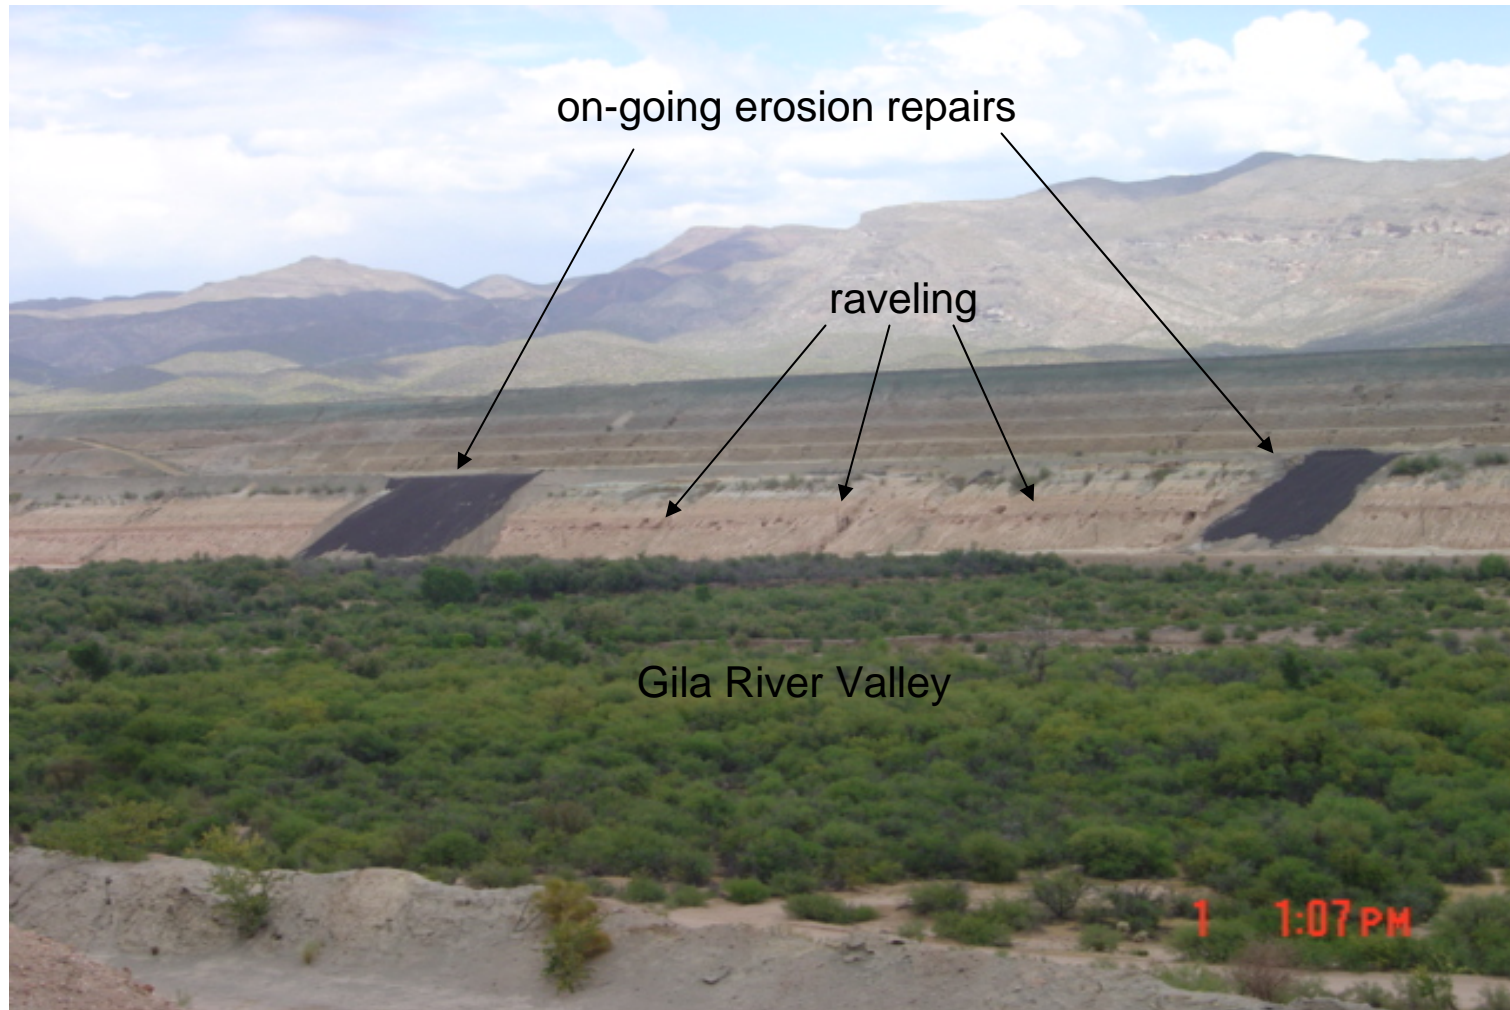
## Photograph 15

Photographs 12 through 17 illustrate panoramic view of southwest (this photo) side of Impoundment BC looking from south to north.

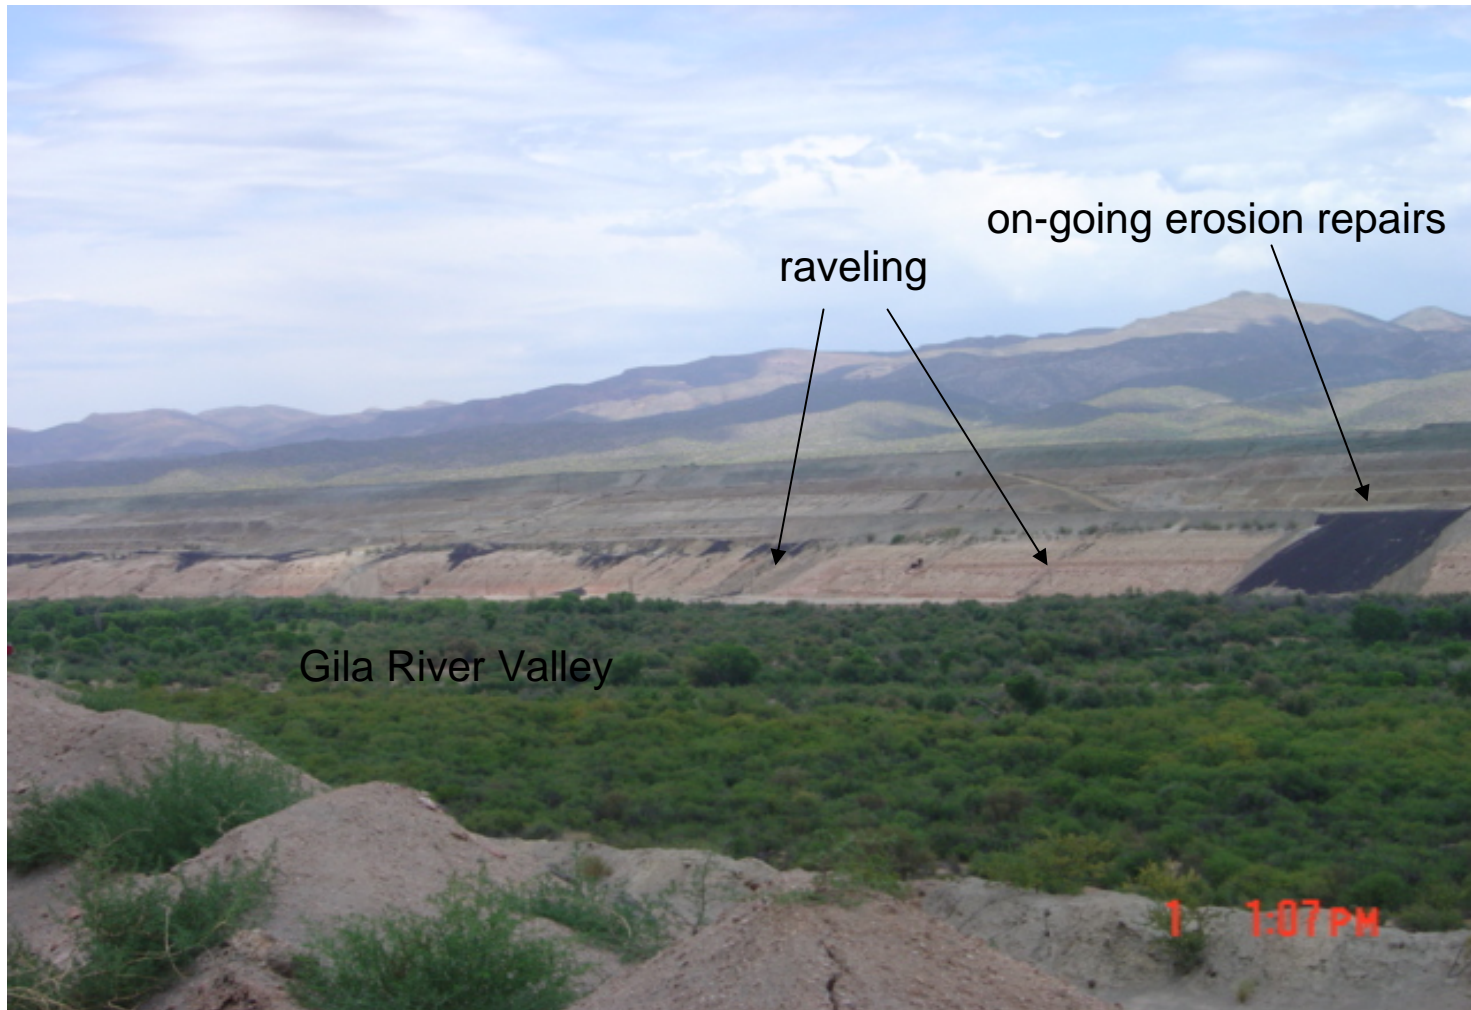
## Photograph 16

Photographs 12 through 17 illustrate panoramic view of southwest (this photo) side of Impoundment BC looking from south to north.

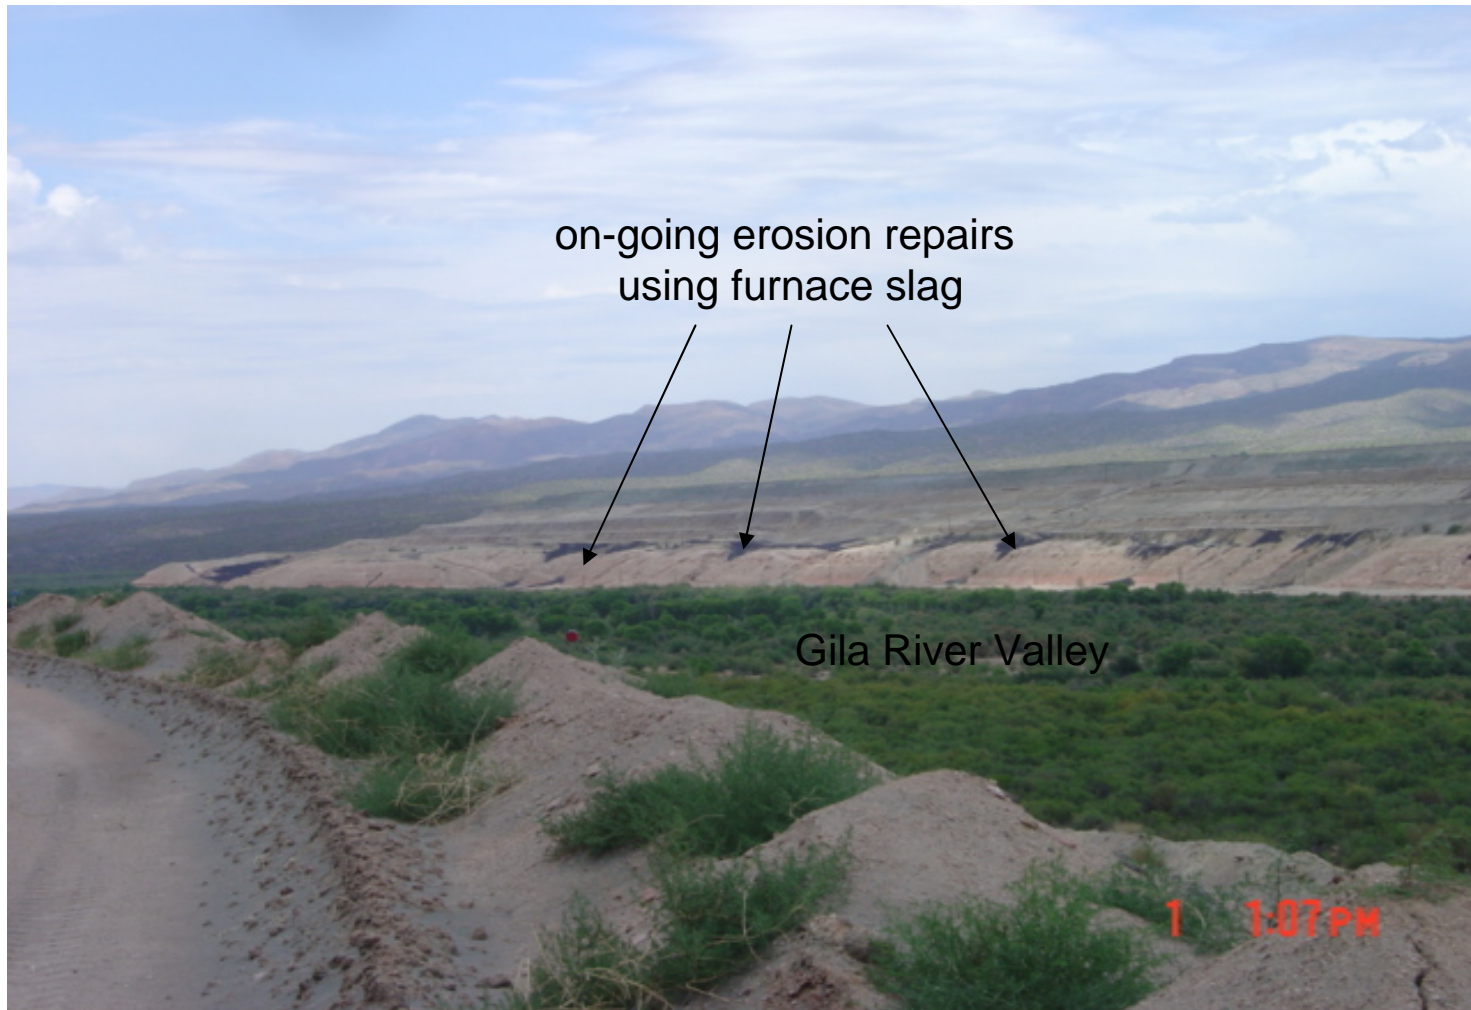
## Photograph 17

**Photographs 12 through 17 illustrate panoramic view of southwest (this photo) side of Impoundment BC looking from south to north.**

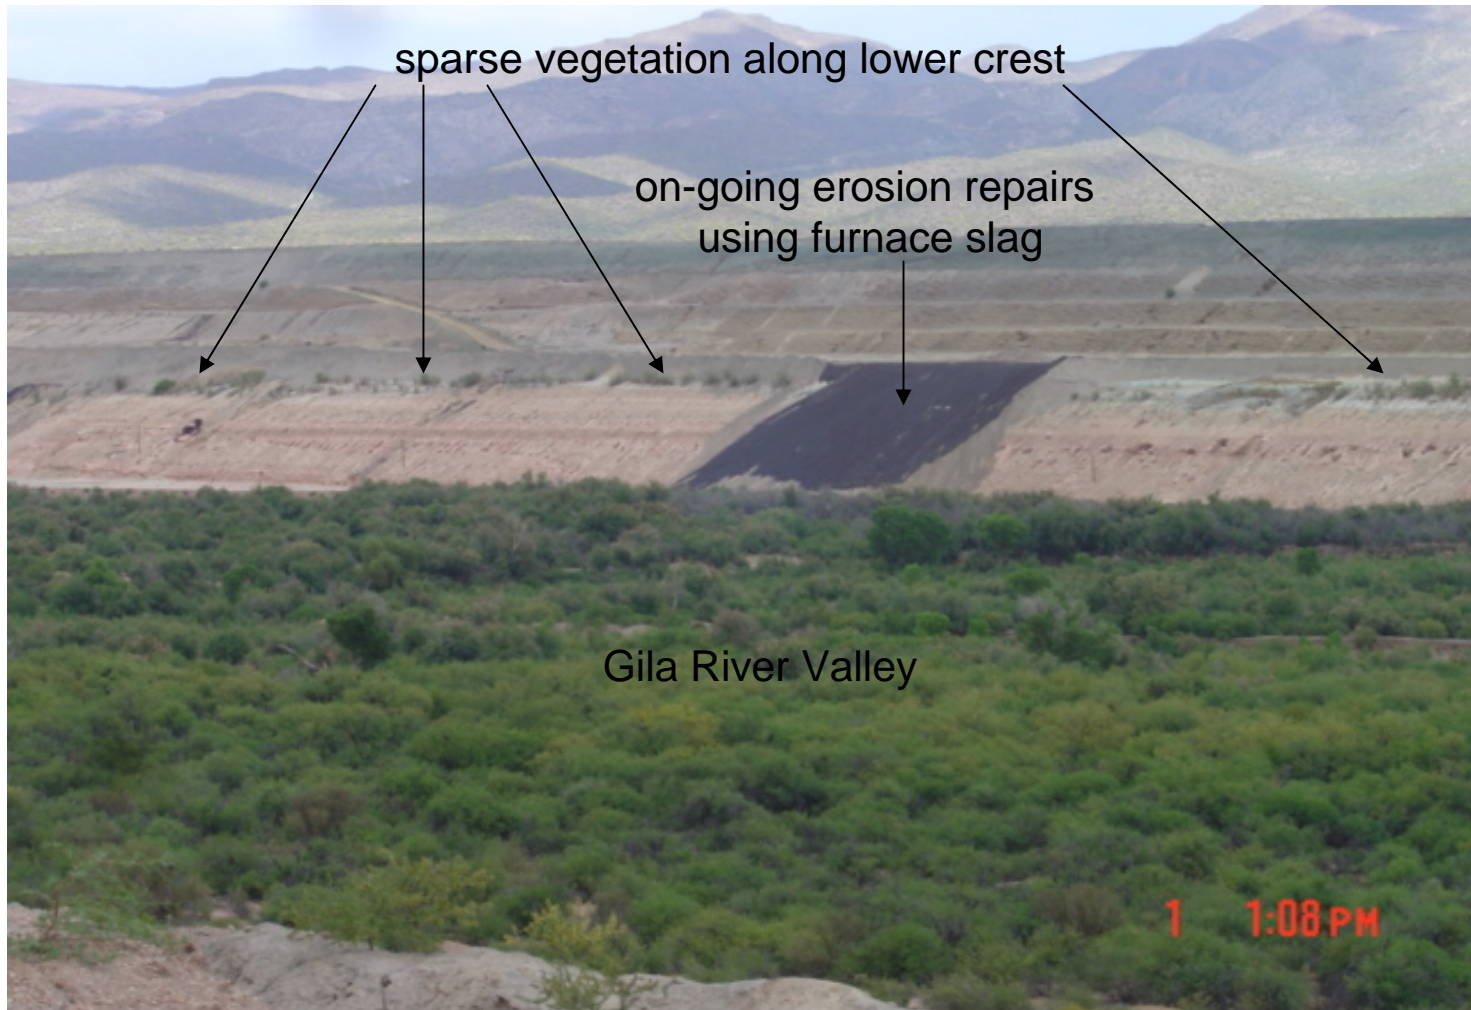
## Photograph 18

**Erosion repair along southwest of Impoundment AB/BC.**

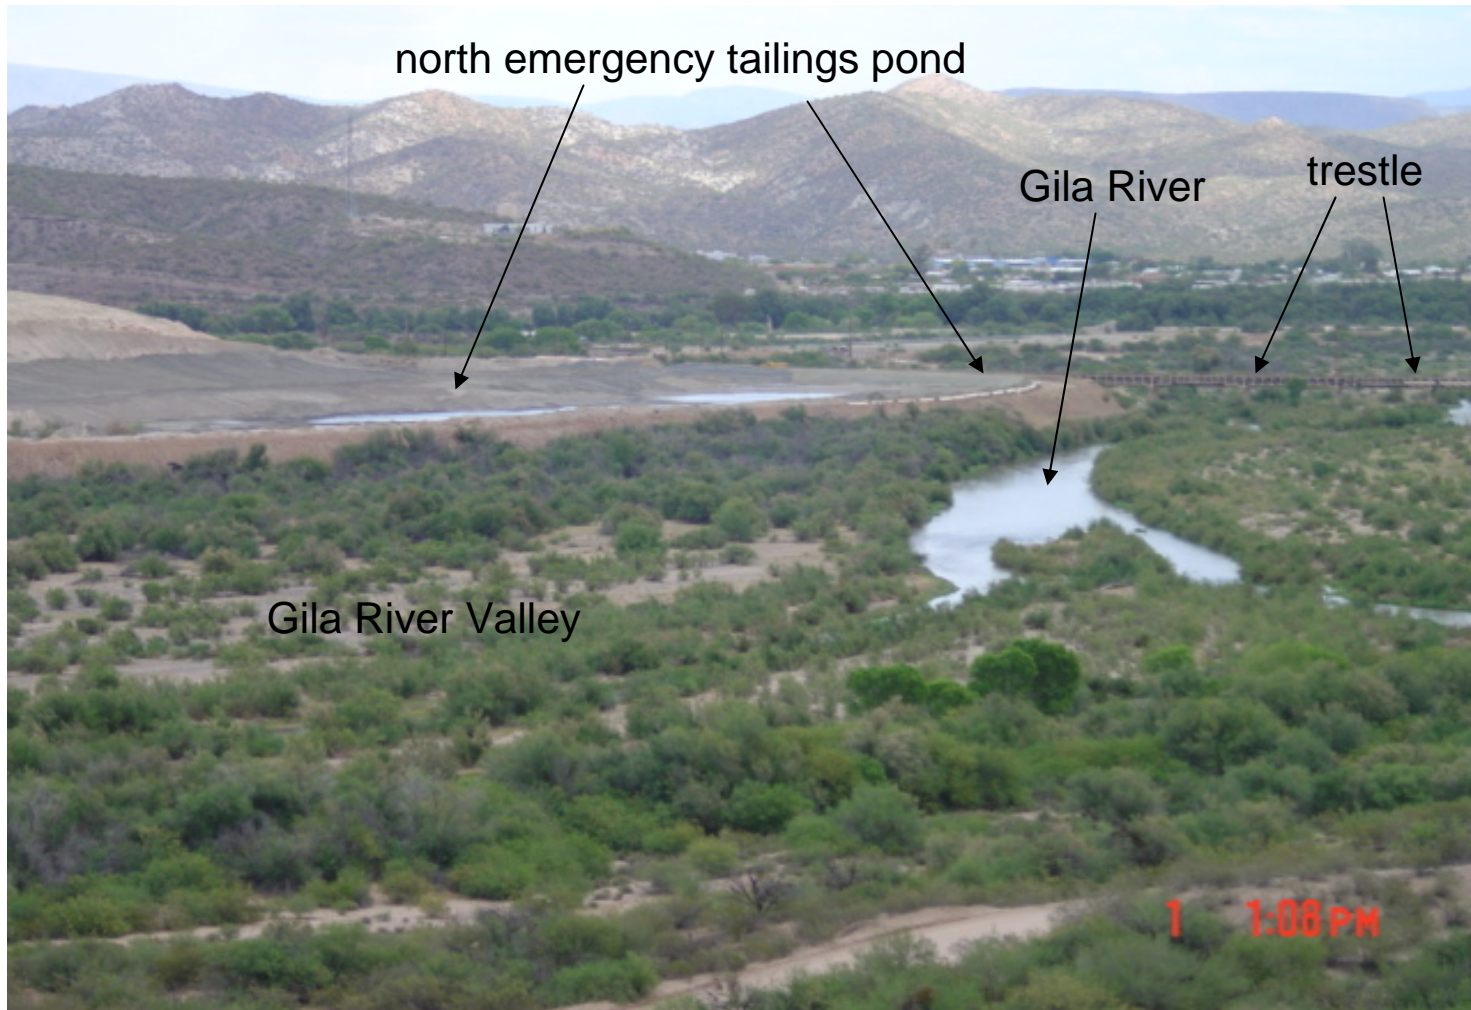
## Photograph 19

**Southwest corner of Impoundment AB/BC near the North Emergency Tailings Pond.**

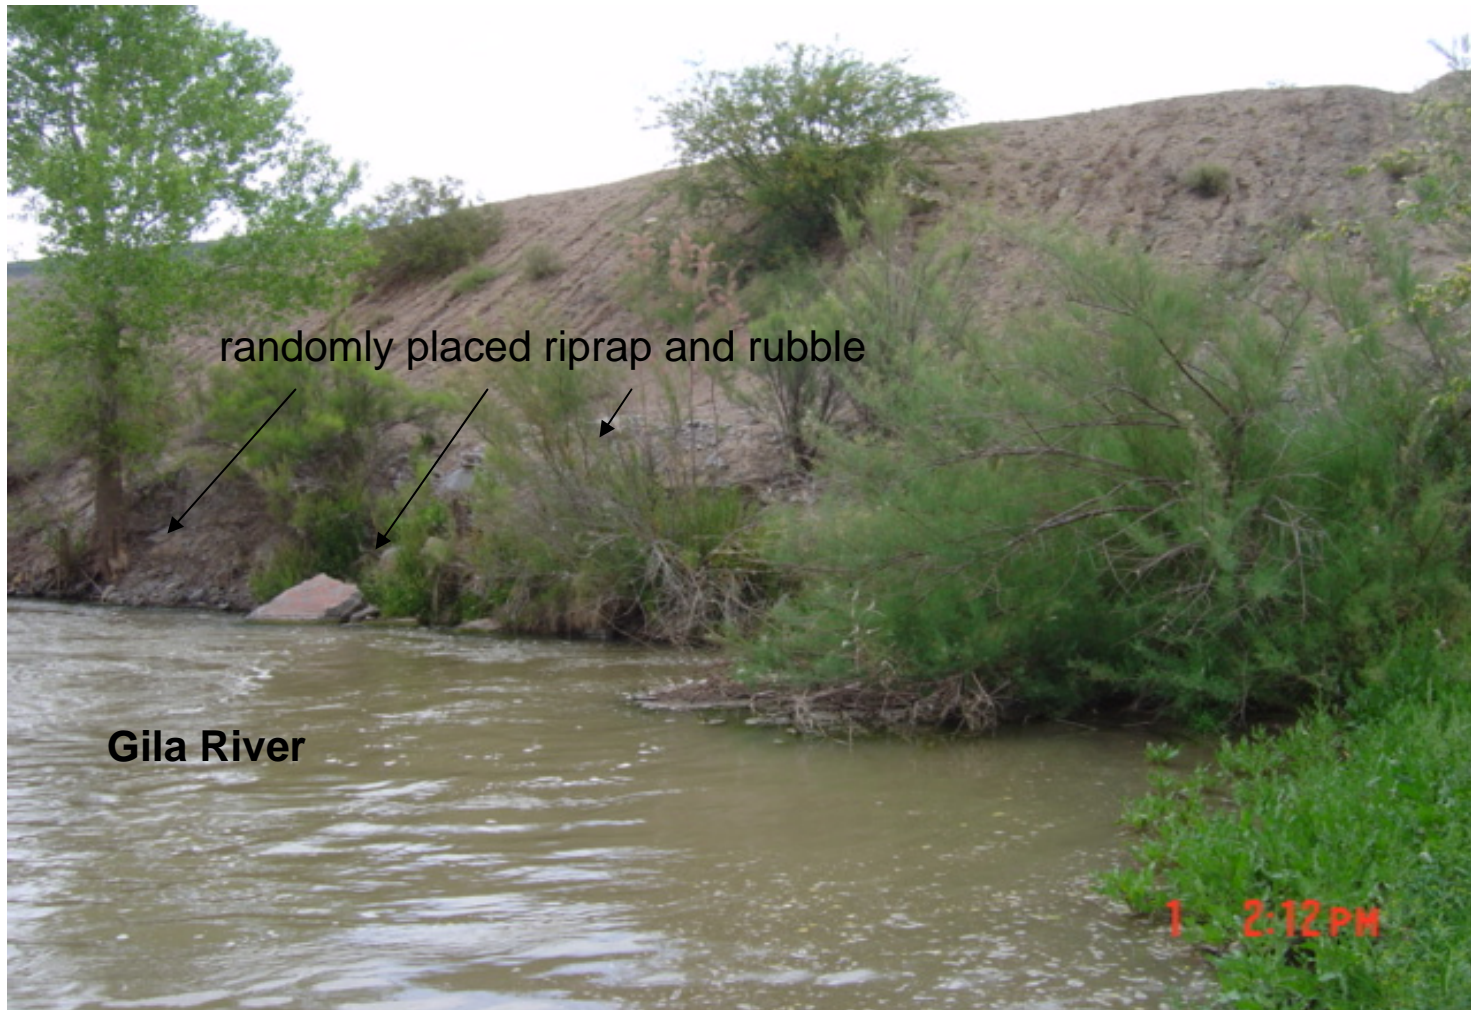
**Photograph 20**

Photographs 20 through 23 show panoramic southeast to northwest view of Gila River at toe of lower berm near Impoundment AB/BC.

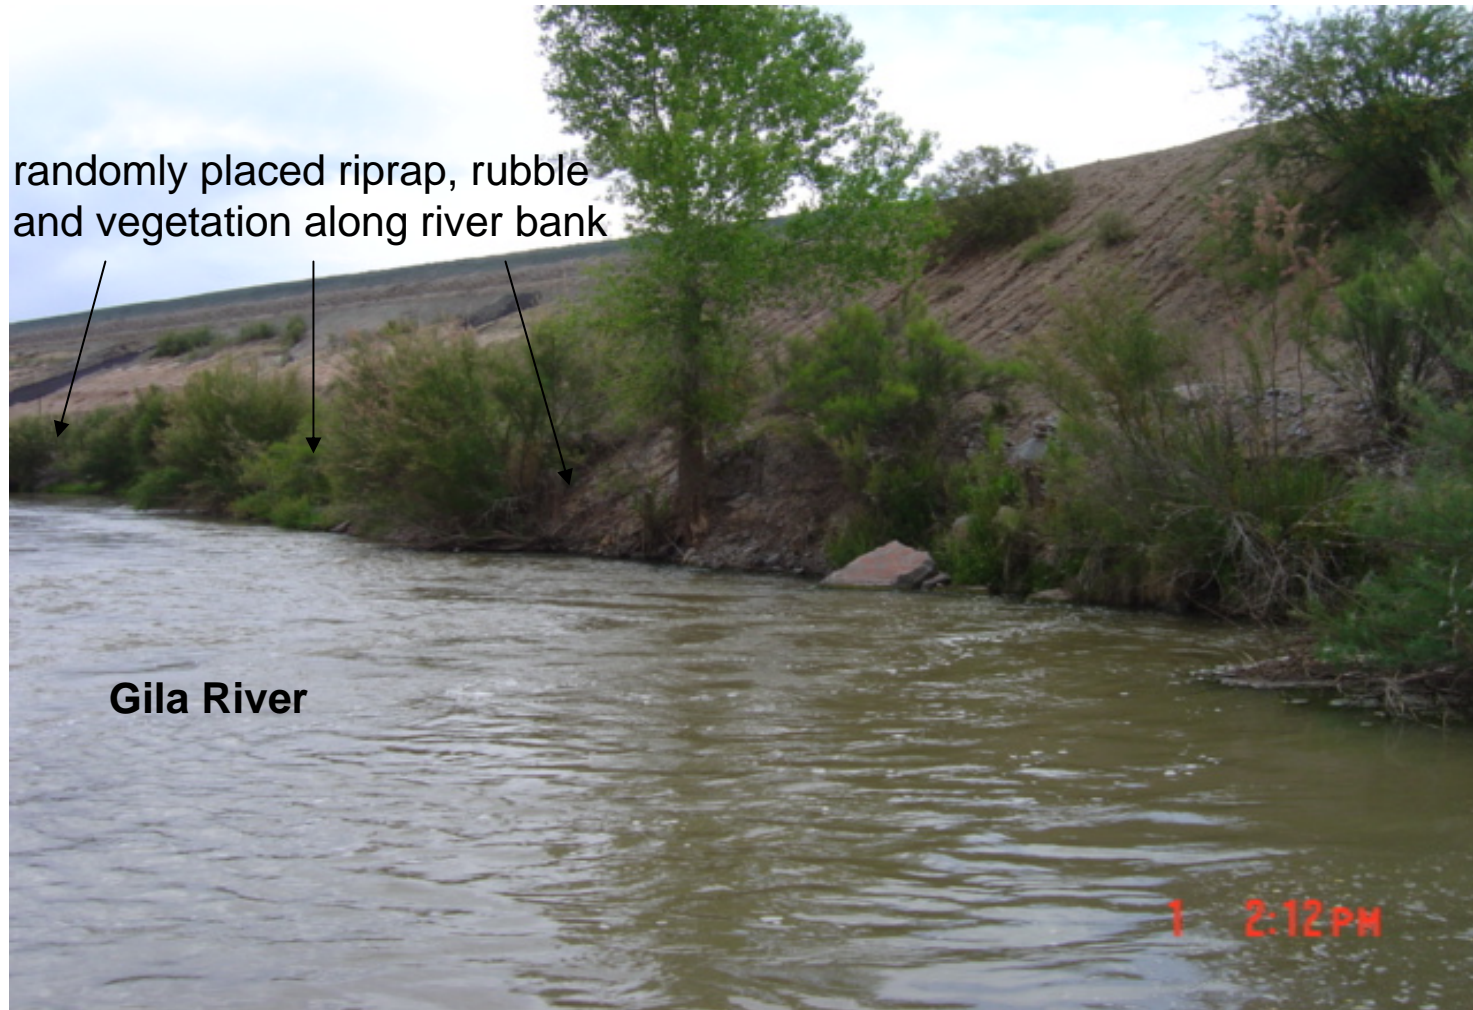
## Photograph 21

Photographs 20 through 23 show panoramic southeast to northwest view of Gila River at toe of lower berm near Impoundment AB/BC.

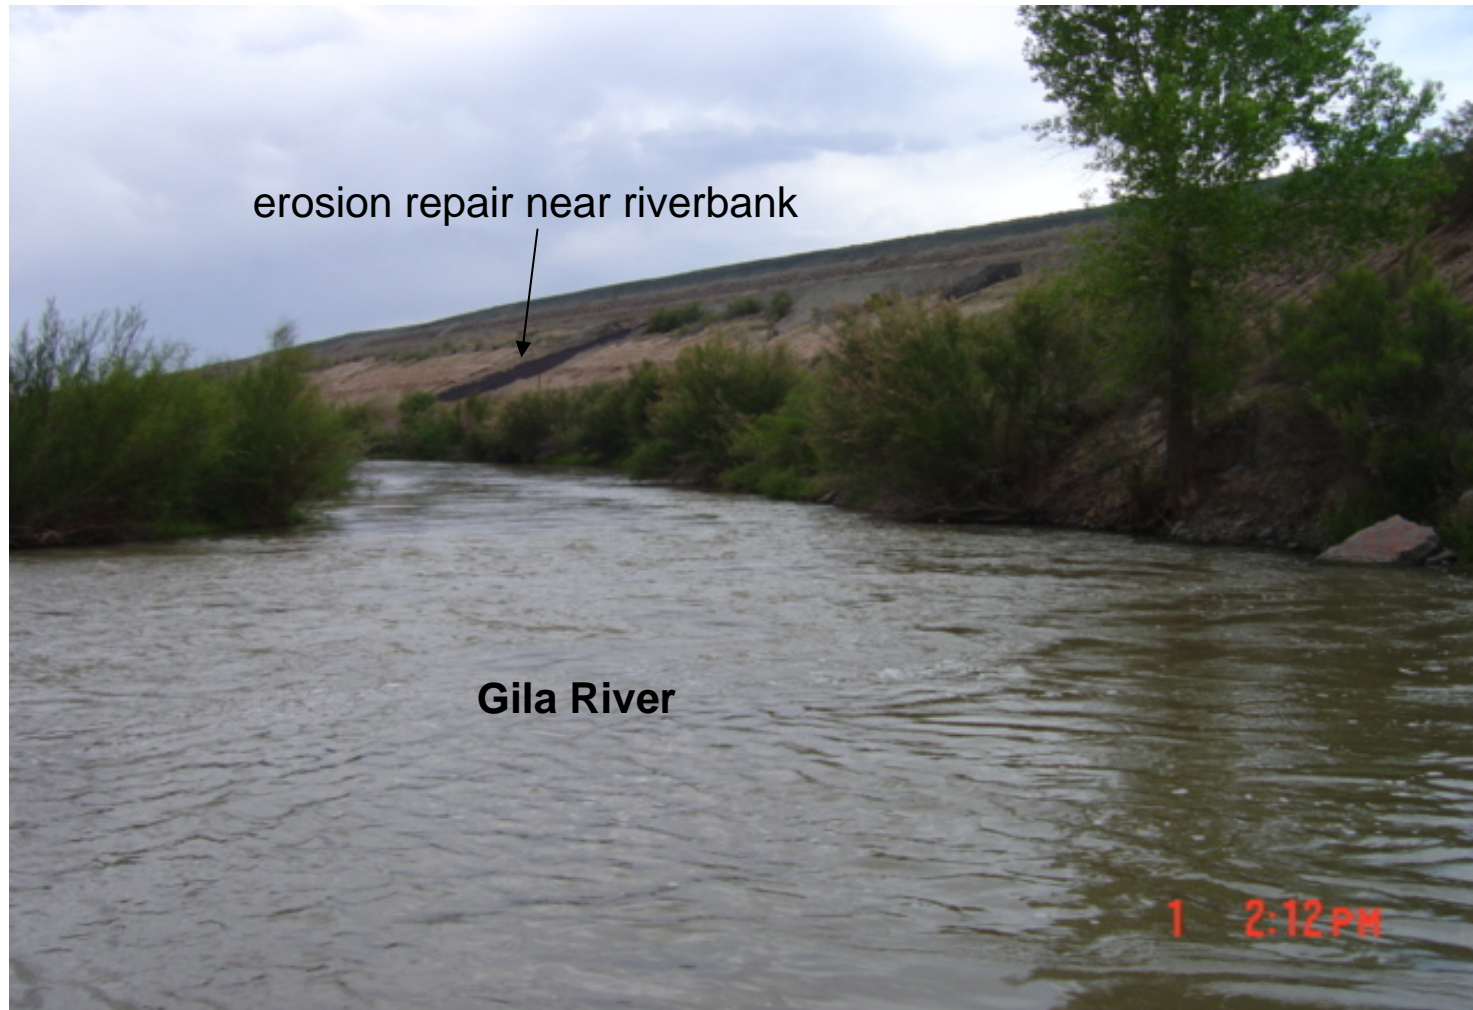
**Photograph 22**

Photographs 20 through 23 show panoramic southeast to northwest view of Gila River at toe of lower berm near Impoundment AB/BC.

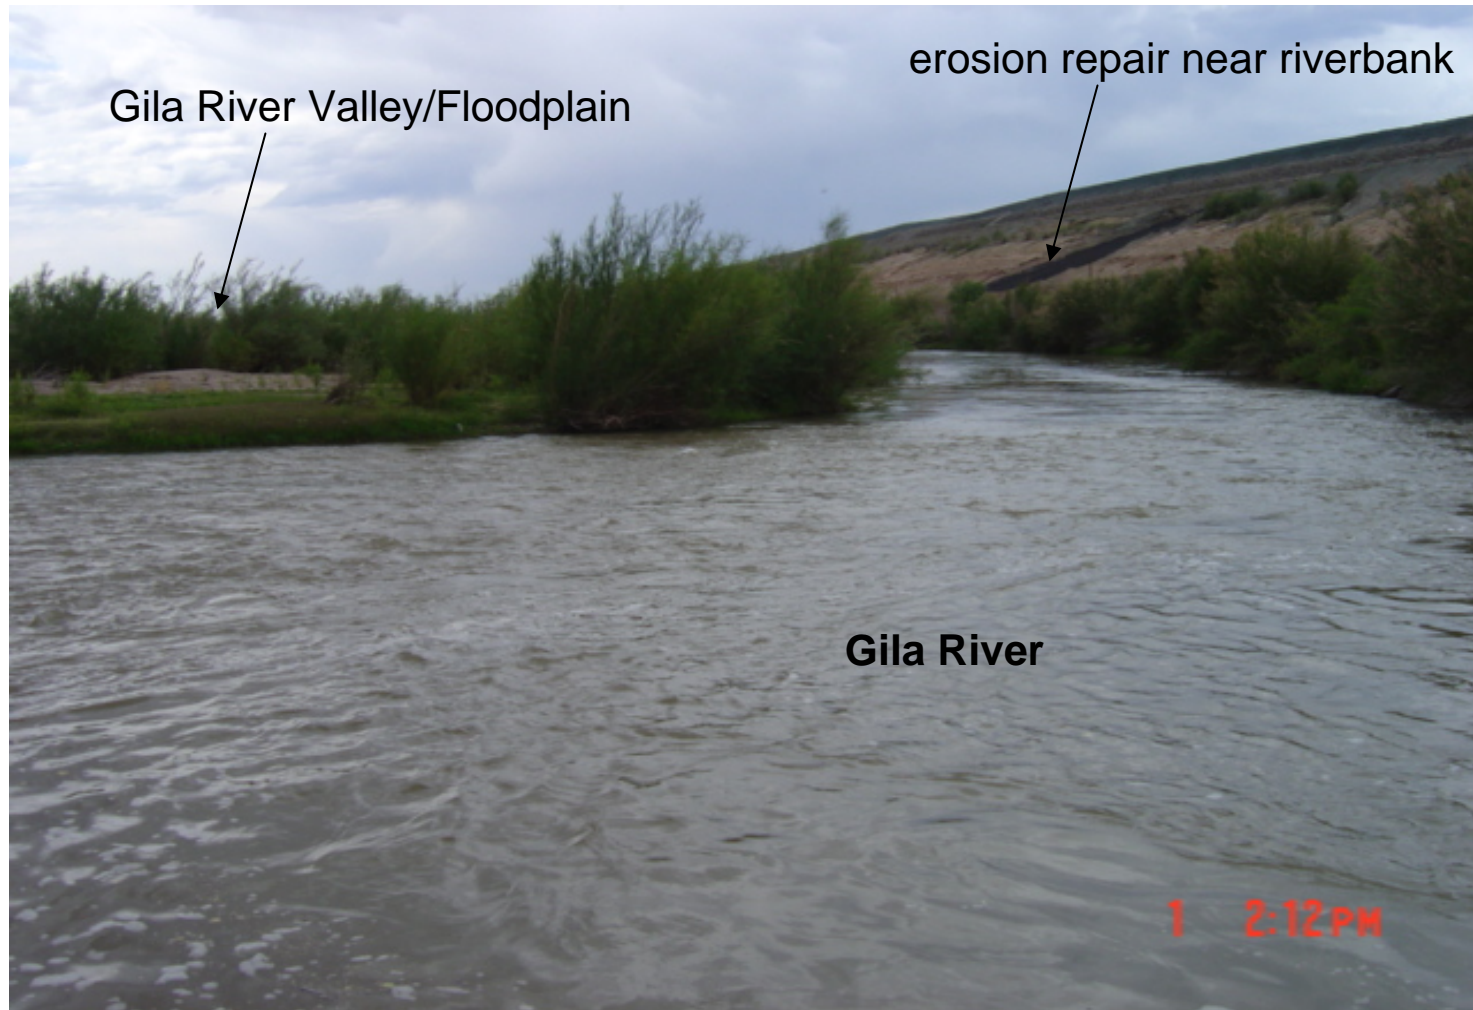
**Photograph 23**

Photographs 20 through 23 show panoramic southeast to northwest view of Gila River at toe of lower berm near Impoundment AB/BC.

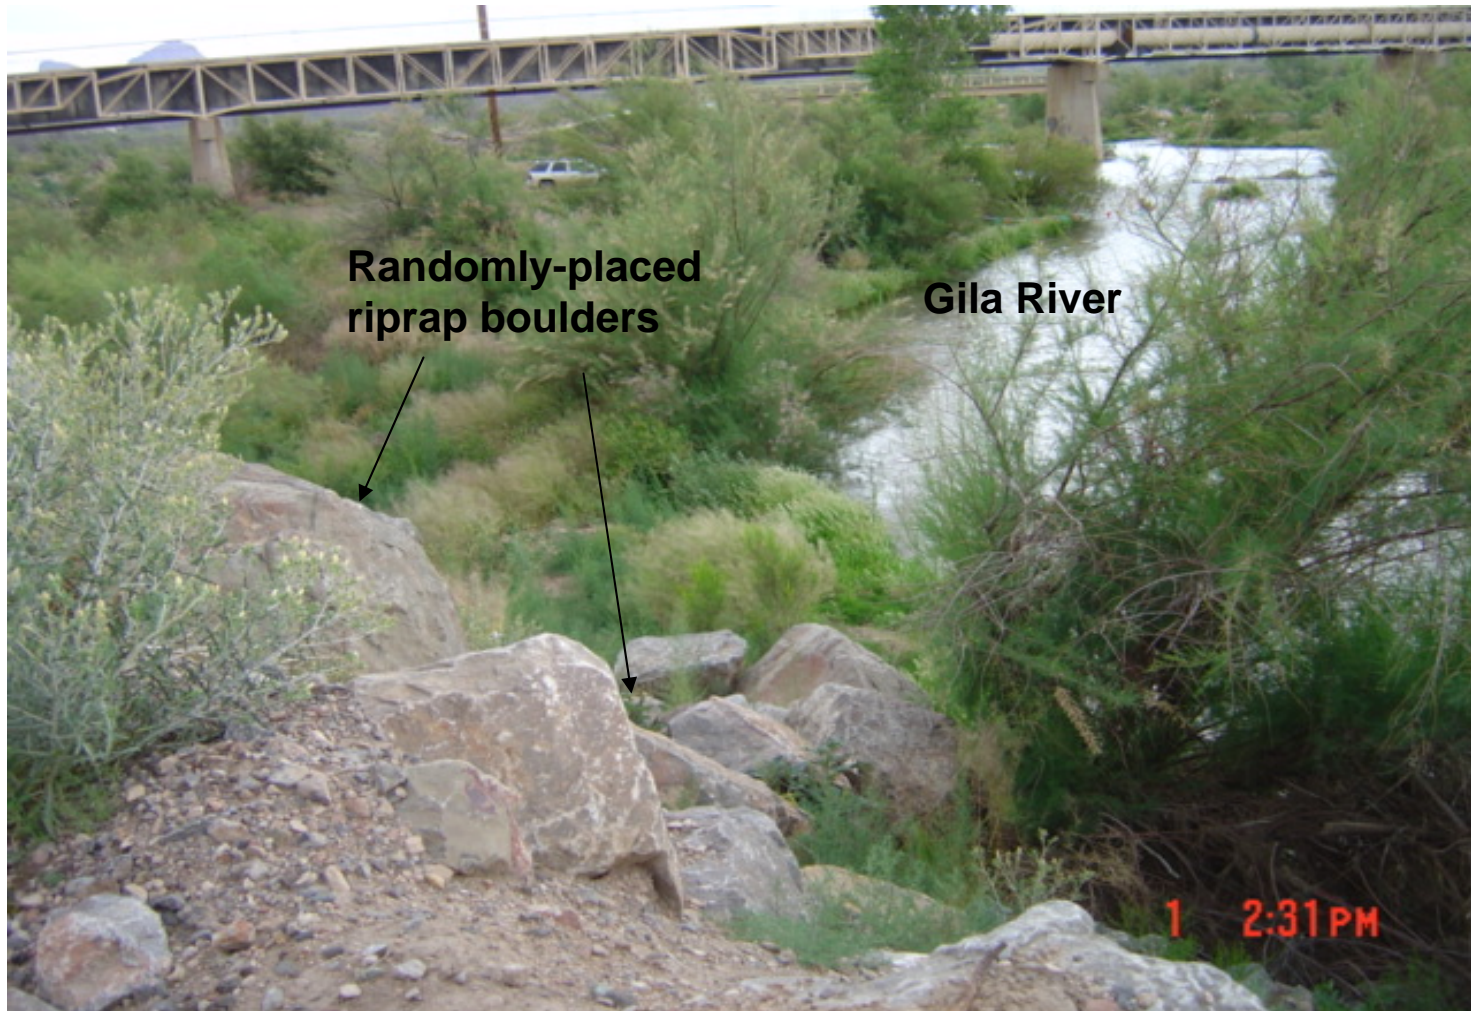
**Photograph 24**

View near southwest corner of North Emergency Tailings Pond and Gila River. Railway trestle in background. Randomly placed riprap boulders in foreground along pond berm.
